Smoke and Dye Testing Summary

High Level Sewershed

Test ID	Test Type	Date Inspected	Company / Super.	Blower MH	Ground Condition	Notification Made?	Total Length
S1028-022	Smoke	8/12/2008	ADS/TM	S09UU_009MH	Dry	Yes	1,870.62

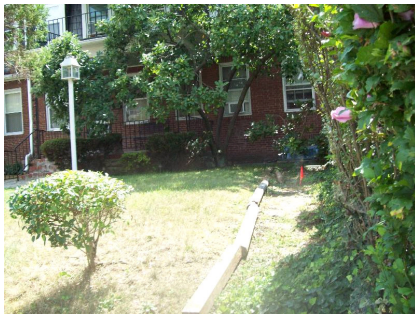
Picture \S1028-022-OB05-P01.jpg

Comments Smoke from cleanout in front yard. 3325 W. Forest Park Ave.

Comments Front of house, 3325 W. Forest Park Ave.

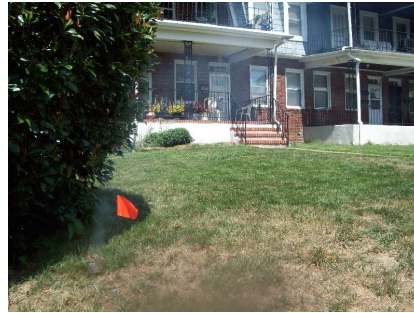
Picture \S1028-022-OB04-P01.jpg

Comments Smoke from cleanout in front yard. 3310 W. Forest Park Ave.

Comments Front of house, 3310 W. Forest Park Ave.

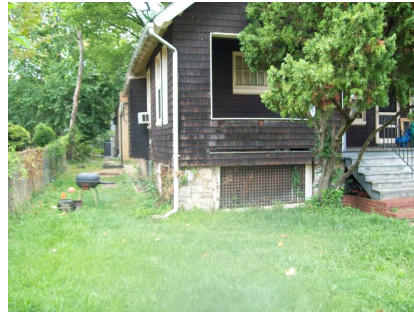
Picture \S1028-022-OB12-P01.jpg

Comments Smoke from cleanout in Side yard of house. 3500 W. Forest Park Ave.

Comments Front of house, 3500 W. Forest Park Ave.
